### Inspection Report Minerals Regulatory Program

**Mine Name:** Cameron #1  
**Operator Name:** Temple Mountain Energy

**Permit number:** M0470036  
**Inspection Date:** March 21, 2006  
**Time:** 2:10-3:30 PM

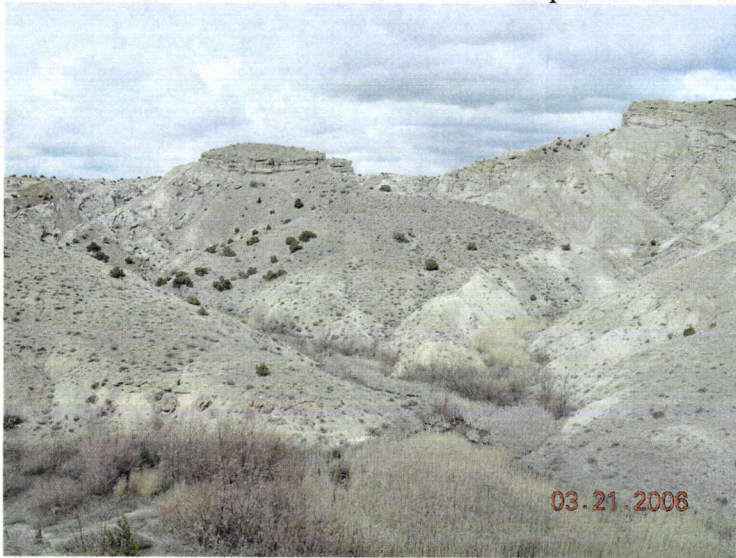
There is a perennial stream running next to the pit. There is some water that collects in the pit and flows through a small cut channel into this stream. The previous operator had anchored straw bales in this channel, and the current operator did the same. The bales have been mostly ripped apart, probably by cattle or possibly by wildlife.

Photo 1. Upper reaches of the stream that flows through the site.

There is currently little or no sediment entering the perennial stream from the mine, but the operator needs to find a way to keep pollutants from getting into the stream, especially if the operation is expanded. Options could include treating the water with a catch basin, sediment pond, or a silt fence.

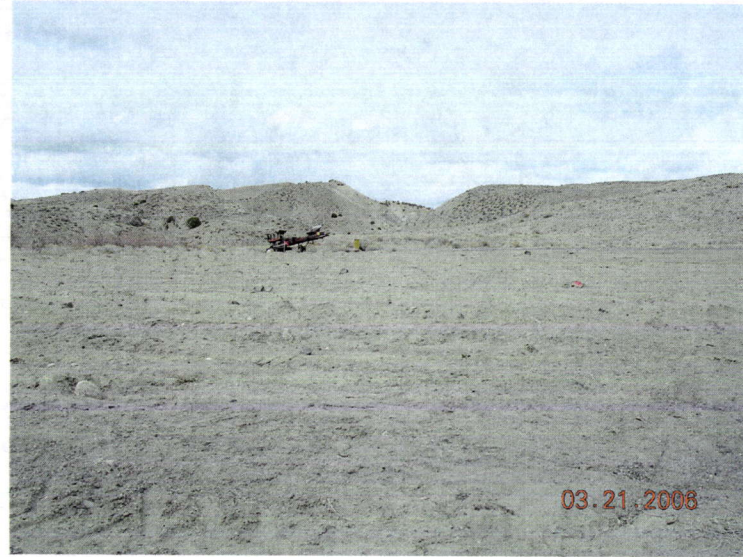
We looked at the area that was graded and seeded last fall (Photo 3), and I was able to find some seeds. I could not see any seedlings, but it is still early in the season (especially this year).

Photo 3. The area that was seeded in the fall of 2005.

The reclaimed area should be monitored to ensure vegetation grows. If not, it may be necessary to reseed.

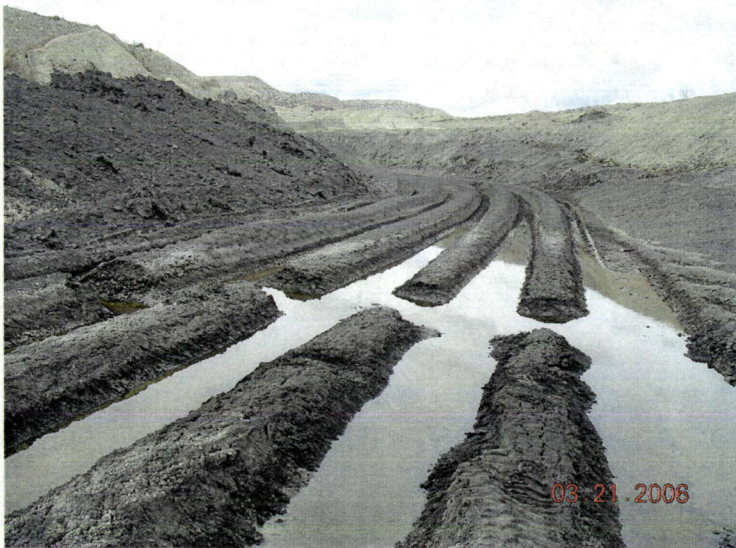
The water that gathers in the pit bottom appears to be mostly ground water but probably also includes meteoric water.

The operator intends to experiment with different mining methods and started with a rotomill. This left windrows of tar sand in the bottom of the pit (Photo 2).

Photo 2. The mine pit with windrows of asphalt. The water could be ground water, meteoric water, or it could be overflow from adjacent streams.

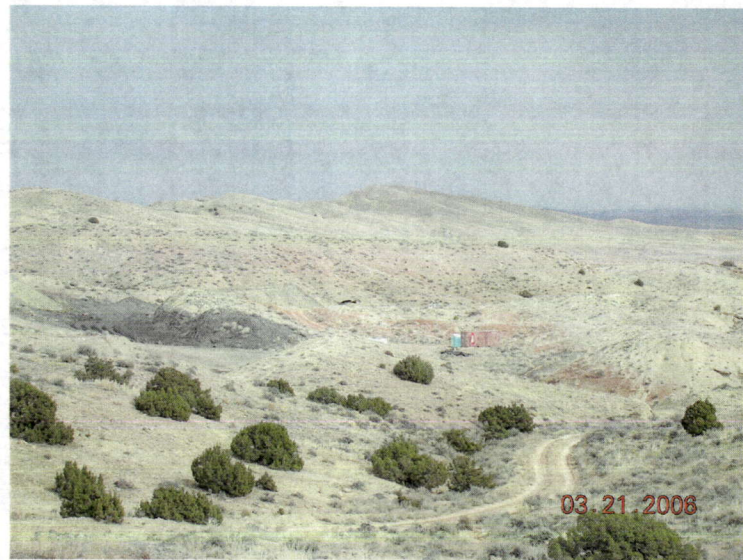
Photo 4. Overview showing the pit (left), and area where the facilities are located.
